Case Report

Innovative method for extraction of a fractured pacemaker lead

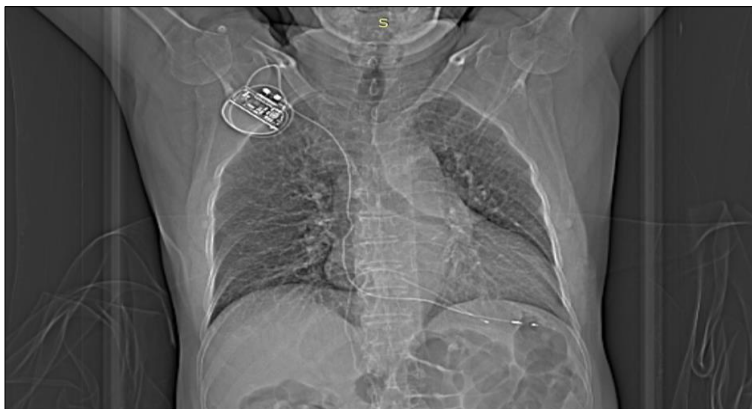
71yr male, known hypertensive on regular medications, diagnosed as degenerative complete heart block and underwent percutaneous permanent pacemaker insertion (Boston scientific – INGEVITY RV lead) on 15/6/2021. After one year he presented with history of mucopurulent foul-smelling discharge at Permanent Pacemaker Insertion site for last 3 months associated with shortness of breath on exertion with NYHA III symptoms. He was evaluated and detected to have pacemaker dysfunction with lead resistance > 3000ohms. After hemodynamic stabilization, he underwent immediate temporary pacemaker insertion. Chest X ray and Computed Tomography Chest revealed lead tip in pericardium (Fig 1).

Fig 1: Right Ventricular screwing lead displaced into the pericardium with fractured proximal end

Patient right ventricular lead is coaxial screwing type, the proximal end is fractured, so we are not able to unscrew the proximal end conventionally with lead clip. We planned to remove the pacemaker lead in four layers, one at a time, since the inner cathode wire contributed primarily to the screw section of the lead. The lead's outermost layer of insulation is taken off with scissors, the outside coil conductor wire (anode) is trimmed and straightened. The insulation's inner layer is taken off and attempted to unscrew the cathode wire using tiny artery forceps, which is the primary inner circuit. The inner pacing wire was securely grasped without causing any damage to it. Using small artery forceps, the wire was turned sixteen times to begin the unscrewing process. The pacemaker lead was successfully extracted without any complications. There is no evidence of pericardial effusion with serial monitoring.
