Original research article

RARE VASCULAR COMPLICATIONS IN CARDIAC IMPLANTABLE ELECTRONIC DEVICE PROCEDURES: A CASE SERIES AND OVERVIEW OF MANAGEMENT

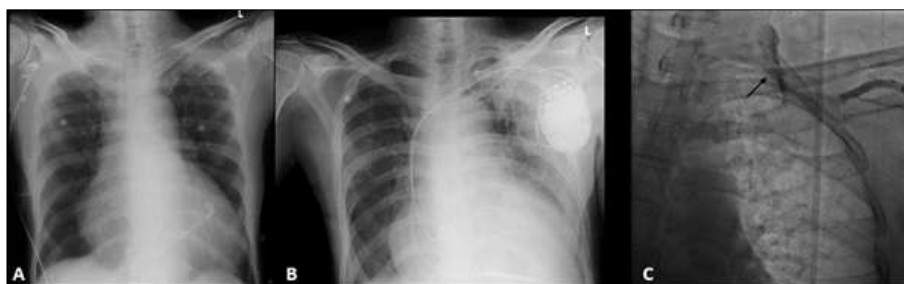
Fig 1: Shows the chest radiograph of case: 1 at admission (A), and 3 hours after the ICD implantation (B). Note the left upper zones infiltrates due to alveolar haemorrhage. Panel C shows the fluoroscopic still-frame of a venogram showing the contrast staining the lung parenchyma (arrow) with suggesting needle injury to the lung (case 2)

A 64-year-old man with coronary artery disease and recurrent scar-related ventricular tachycardia underwent a defibrillator implantation. He developed cough and haemoptysis 2 hours after the procedure, but no pain or dyspnoea. A chest radiograph showed infiltrates in the right upper zone and the possibility of alveolar haemorrhage was considered (Fig 1). He was managed conservatively and his haemoptysis subsided in 3 days, with resolution of the X ray findings in a radiogram repeated after 2 weeks. He recovered uneventfully.

A 48-year-old gentleman developed sudden haemoptysis soon after attempted venous access while undergoing a PPM implantation for CHB. A venogram was done which showed the contrast staining the lung tissue (Fig 1). A separate venous access was taken and the implantation completed. The haemoptysis persisted for 2 days after which it subsided spontaneously. There was no evidence of haemothorax /pneumothorax, nor any desaturation, and he recovered uneventfully.

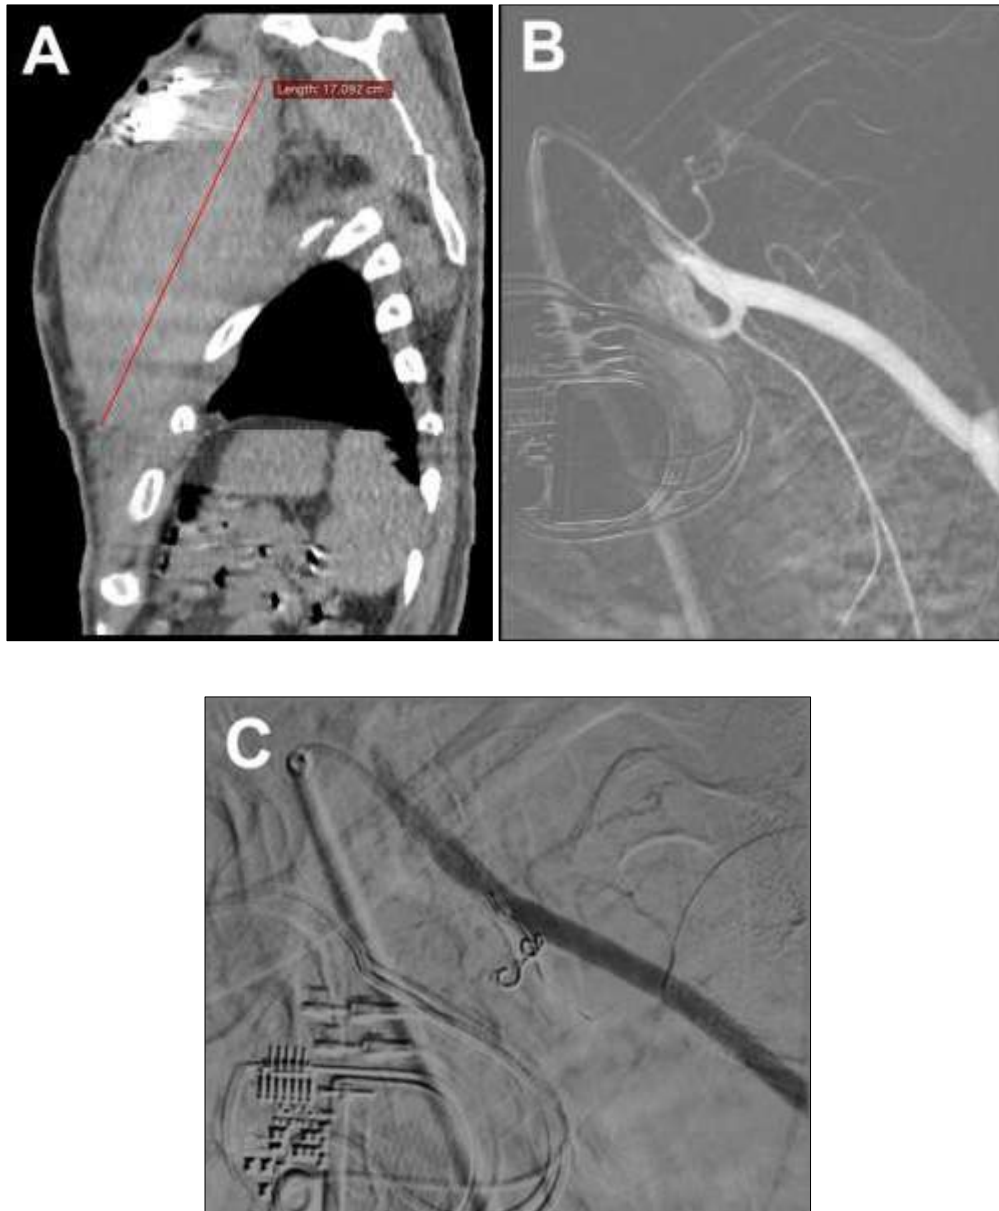
Fig 2: (From Case: 3) Panel A shows the CT scan showing large haematoma (16x8cm) at pacemaker site with no intrathoracic extension. Panel B shows Subclavian angiogram showing free pulsatile flow from a branch of subclavian artery Panel C shows Post coil occlusion showing complete cessation of flow

A 62-year hypertensive male underwent dual chamber permanent pacemaker (PPM) implantation presented on day 10, with acute onset painful increase in the size of the CIED pocket accompanied by a postural hypotension and a drop-in haemoglobin levels by 4grams/dl. An urgent non-contrast CT revealed a large hematoma at the site of the CIED implant, with no fluid collection within the pleural spaces (Fig 2A). Suspecting an arterial bleed, left sub-clavian arteriogram obtained using the 6F Judkins right coronary artery catheter via the right femoral arterial access. It revealed free pulsatile extravasation of blood originating from the thoraco-acromial (TA) branch of left axillary artery (Fig 2B). Selective cannulation of culprit artery done by 4F LIMA coronary catheter with 7F cook shuttle sheath support was done. 2 Coils the first one (0.018 inch, 3x3 mm, Nester, Cook Medical) were deployed into the bleeding TA

branch distally with care taken that their proximal end did not protrude into the lumen of the main subclavian artery, and the second one (0.035, 2x3, Reye, Cook medical) was also deployed within the same branch to completely occlude the culprit vessel (Fig 2C). After 2 days the patient was discharged without event and no infection at 2 months of follow-up.
